Bulletin #: TB970701 Parachute Swivel De-burring Date: 7/3/97 Page 1 of 1

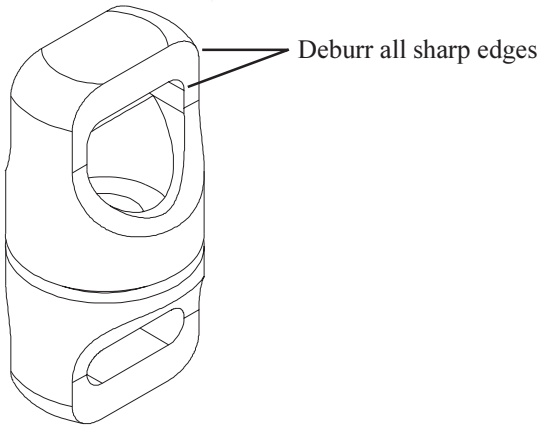
Parachute Swivel

A number of early model parachute swivels were produced with sharp edges which could cut the parachute bridle webbing during a deployment. (The swivel pictured below is the later model, which is not subject to this problem). Early model swivels are aluminum colored, while later models are anodized blue. Not all aluminum colored swivels are subject to this problem, but all swivels which are subject are aluminum colored.

To inspect your swivel, pull the webbing towards the side of the slot and feel the edges along the top of the slot. If they feel sharp, you need to debur these edges, and also the edges in the corners and on the sides of the webbing slots with a small file. It is not necessary to remove the bridle to do this. You should inspect the bridle during this process for any sign of damage.
